## MCF5282 Chip Errata

### Silicon Revision: All

This document identifies implementation differences between the MCF5281/82 processors and the description contained in the *MCF5282 ColdFire® Reference Manual*. Refer to <http://www.freescale.com/coldfire> for the latest updates.

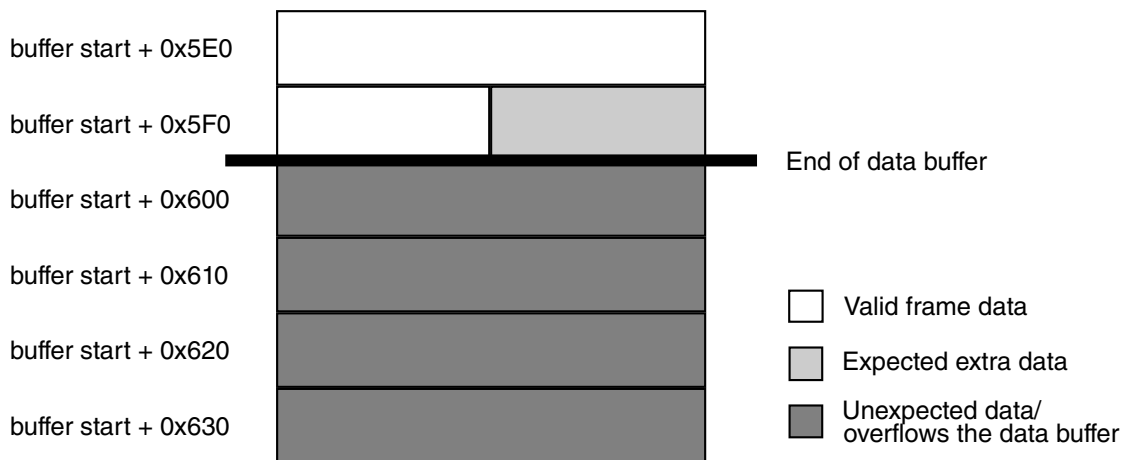
**Figure 1. Buffer Overrun Example**

## SECF009: FEC Receive Buffer Overrun in 10BaseT Mode

**Description:** When the FEC is connected to a 10BaseT network, if length of the data stored in a descriptor is not evenly divisible by 16 (not line-aligned), the FEC writes extra lines at the end of the buffer. The entire line that contains the last valid data is written and at least one extra line, but

up to four lines after the end of the valid data can also be written. In most cases, this is not a problem because the extra lines of data continue falling within the limits of the buffer. However, if the valid data ends near the end of the buffer, the extra lines written by the FEC might be outside of the data buffer. This leads to corruption of the next buffer, descriptor, data, or code stored in the adjacent memory.

For example, as shown in the figure below, if the max buffer size is programmed to 0x600 and a frame that is 0x5F8 bytes long is received, a line is written starting at buffer start + 0x5F0. The first half of the line at buffer start + 0x5F0 is valid frame data that should be processed by the FEC driver; the second half of the line is additional data that is written because the FEC only writes complete lines. This data should be ignored by the FEC driver. So far, this is correct FEC behavior as originally specified. However, the FEC repeats the last line of valid data a number of times. The line at buffer start + 0x600 is written, and as many as three additional lines beyond the end of the data buffer could be written.

**Workaround:** Only use 100BaseT.

**Workaround:** Allocate extra lines for the receive data buffers. The actual allocated memory for each buffer should be equal to the receive buffer size programmed in the FEC's EMRBR register plus four lines (16 byte-sized lines).

**Workaround:** Program the data buffer size one line larger than the max packet size (data buffer size = EMRBR + 0x40).
