MCF5282 Chip Errata

Silicon Revision: All

Document Number: MCF5282DE
Rev. 8, 02/2015

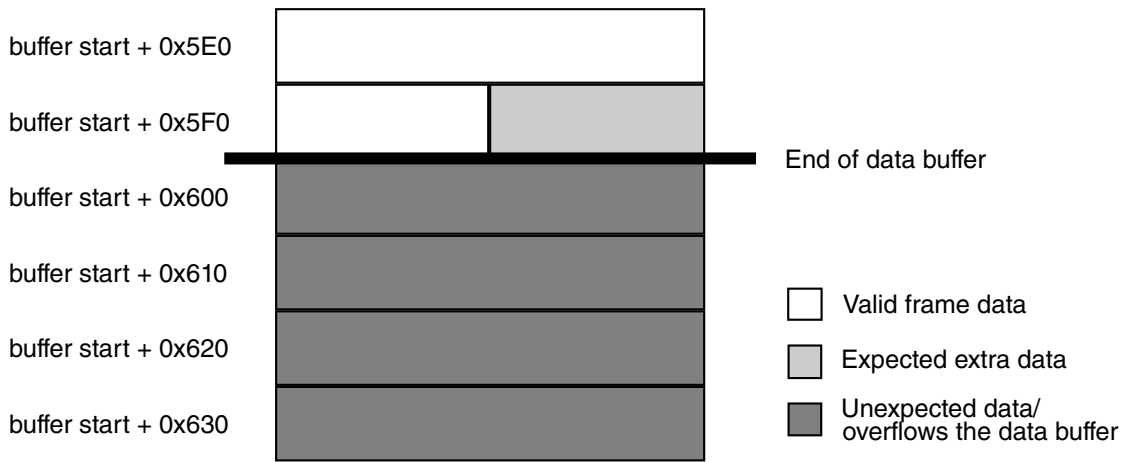
Figure 1. Buffer Overrun Example

Description: When the FEC is connected to a 10BaseT network, if length of the data stored in a descriptor is not evenly divisible by 16 (not line-aligned), the FEC writes extra lines at the end of the buffer. The entire line that contains the last valid data is written and at least one extra line, but

up to four lines after the end of the valid data can also be written. In most cases, this is not a problem because the extra lines of data continue falling within the limits of the buffer. However, if the valid data ends near the end of the buffer, the extra lines written by the FEC might be outside of the data buffer. This leads to corruption of the next buffer, descriptor, data, or code stored in the adjacent memory.

For example, as shown in the figure below, if the max buffer size is programmed to 0x600 and a frame that is 0x5F8 bytes long is received, a line is written starting at buffer start + 0x5F0. The first half of the line at buffer start + 0x5F0 is valid frame data that should be processed by the FEC driver; the second half of the line is additional data that is written because the FEC only writes complete lines. This data should be ignored by the FEC driver. So far, this is correct FEC behavior as originally specified. However, the FEC repeats the last line of valid data a number of times. The line at buffer start + 0x600 is written, and as many as three additional lines beyond the end of the data buffer could be written.

Workaround: Only use 100BaseT.

Workaround: Allocate extra lines for the receive data buffers. The actual allocated memory for each buffer should be equal to the receive buffer size programmed in the FEC's EMRBR register plus four lines (16 byte-sized lines).

Workaround: Program the data buffer size one line larger than the max packet size (data buffer size = EMRBR + 0x40).
