dsPIC30F1010/202X Family Silicon Errata and Data Sheet Clarification

The dsPIC30F1010/202X family devices that you have received conform functionally to the current Device Data Sheet (DS70178C), except for the anomalies described in this document.

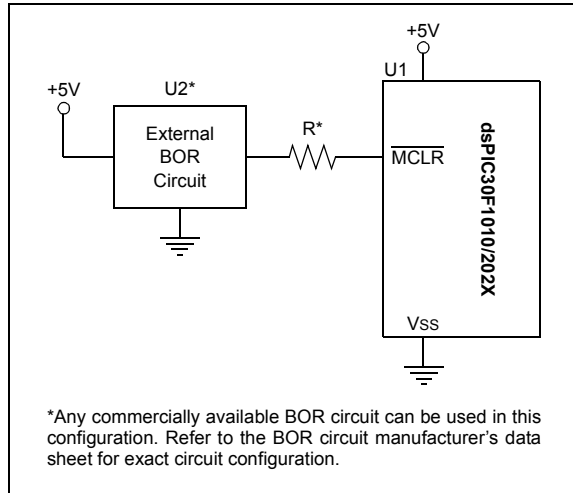
FIGURE 1:

It is recommended that an external Brown-out Reset (BOR) circuit be used to hold the device in Reset, during a brown-out event, to overcome this problem. The external BOR circuit will use the MCLR pin to hold the device in Reset. The following work around, in combination with the external BOR circuit, will ensure that the device is cleanly reset after a brown-out event occurs.

The dsPIC DSC SMPS device must be powered up with the PLL disabled, the Fail-Safe Clock Monitor (FSCM) enabled and clock switching enabled. The PLL should be enabled in software via a clock switch after the device is reset (refer to **Section 29. "Oscillator"** (DS70268) in the "dsPIC30F Family Reference Manual" for details on clock switching). This ensures that the MCLR pin is functional and that the device can be reset by an external BOR circuit (see [Figure 1](#)).
