1. Description

The AT32UC3B is a complete System-On-Chip microcontroller based on the AVR32 UC RISC processor running at frequencies up to 60 MHz. AVR32 UC is a high-performance 32-bit RISC microprocessor core, designed for cost-sensitive embedded applications, with particular emphasis on low power consumption, high code density and high performance.

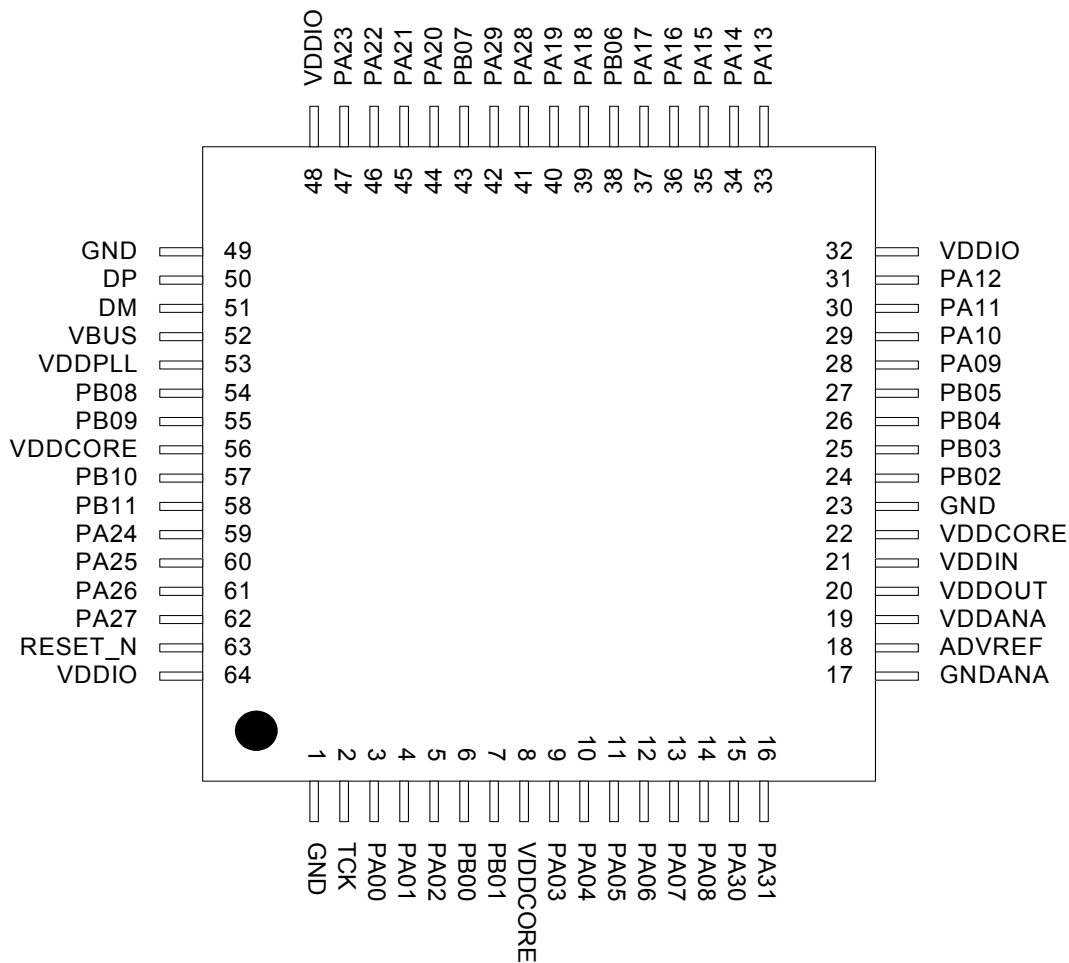
Figure 4-1. TQFP64 / QFN64 Pinout

The device pins are multiplexed with peripheral functions as described in the Peripheral Multiplexing on I/O Line section.

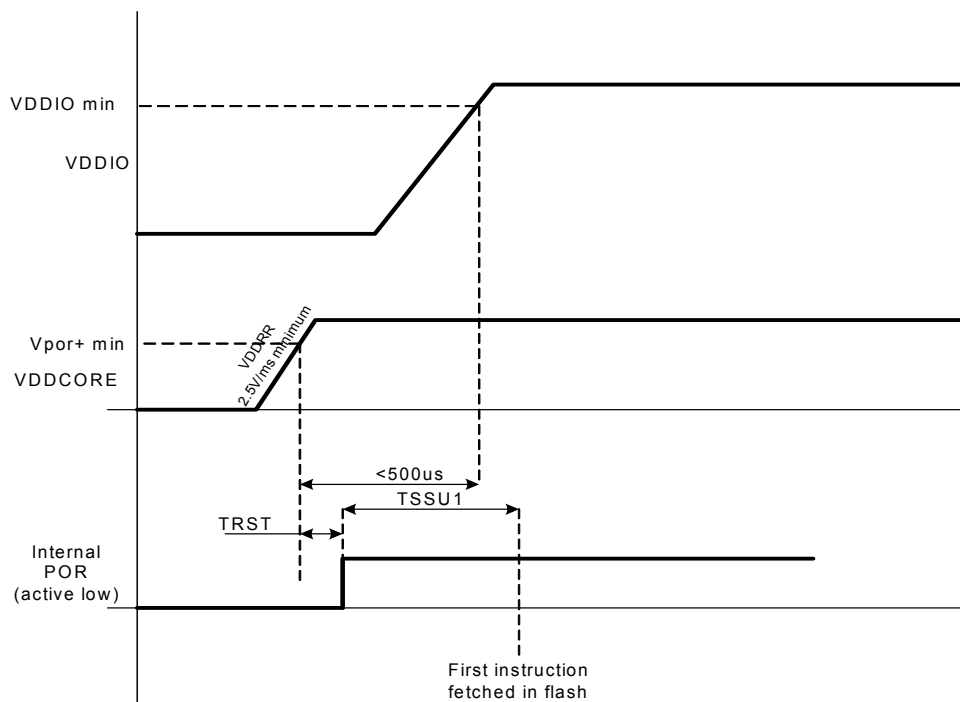
Figure 9-4. Dual Supply Configuration

Therefore VDDCORE rise rate (VDDRR) must be equal or superior to 2.5V/ms and VDDIO must reach VDDIO min value before 500 us ($< TRST + TSSU1$) after VDDCORE has reached V_{POR+} min value.

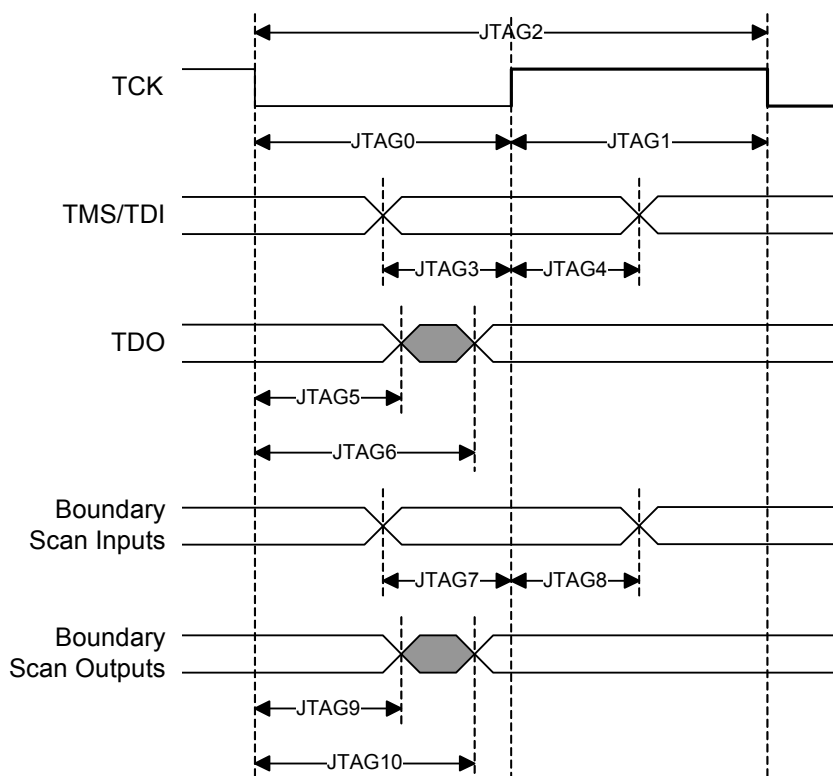
Figure 9-6. JTAG Interface Signals

Table 9-26. JTAG Timings⁽¹⁾

Symbol	Parameter	Conditions	Min	Max	Units
JTAG0	TCK Low Half-period	V_{DDIO} from 3.0V to 3.6V, maximum external capacitor = 40pF	23.2		ns
JTAG1	TCK High Half-period		8.8		ns
JTAG2	TCK Period		32.0		ns
JTAG3	TDI, TMS Setup before TCK High		3.9		ns
JTAG4	TDI, TMS Hold after TCK High		0.6		ns
JTAG5	TDO Hold Time		4.5		ns
JTAG6	TCK Low to TDO Valid			23.2	ns
JTAG7	Boundary Scan Inputs Setup Time		0		ns
JTAG8	Boundary Scan Inputs Hold Time		5.0		ns
JTAG9	Boundary Scan Outputs Hold Time		8.7		ns
JTAG10	TCK to Boundary Scan Outputs Valid			17.7	ns

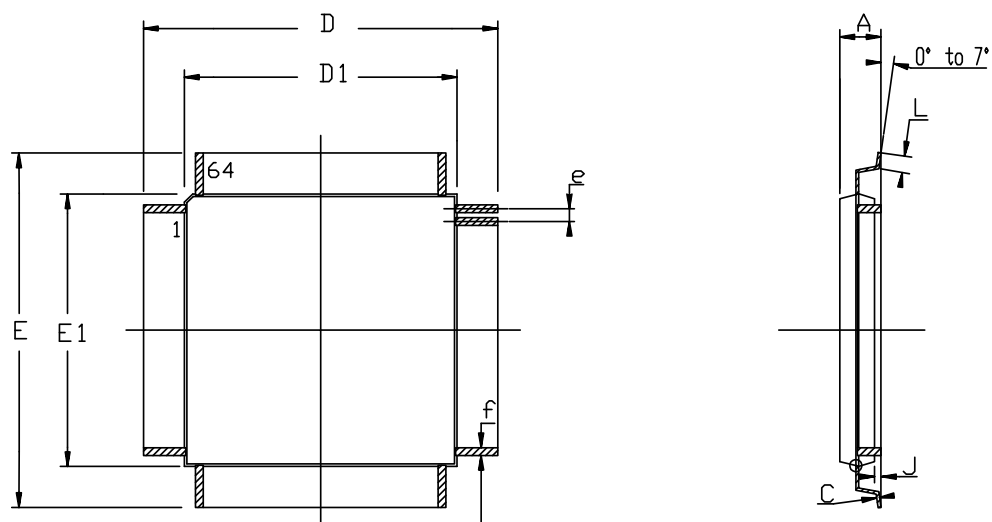
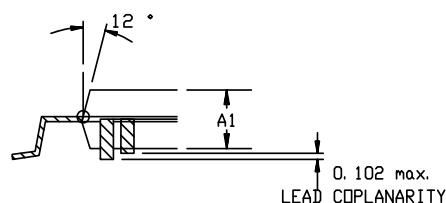
Figure 10-1. TQFP-64 package drawing

COMMON DIMENSIONS IN MM

SYMBOL	Min	Max	NOTES
A	----	1.20	
A1	0.95	1.05	
C	0.09	0.20	
D	12.00 BSC		
D1	10.00 BSC		
E	12.00 BSC		
E1	10.00 BSC		
J	0.05	0.15	
L	0.45	0.75	
e	0.50 BSC		
f	0.17	0.27

JEDEC Drawing Reference	MS-026
JESD97 Classification	e3

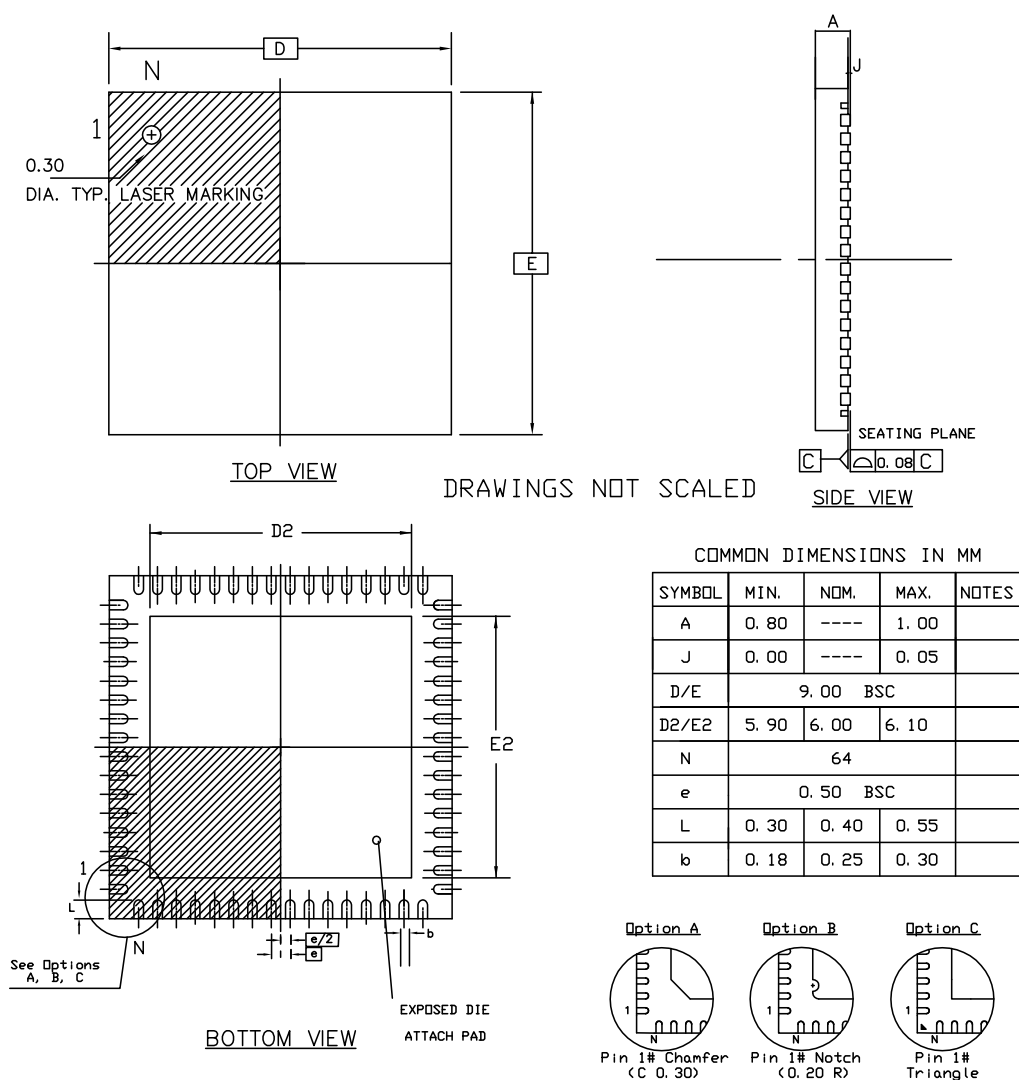
Figure 10-3. QFN-64 package drawing

Compliant JEDEC Standard MO-220 variation VMMD-3
