Product Status	Active
Core Processor	AVR
Core Size	32-Bit Single-Core
Speed	60MHz
Connectivity	I ² C, IrDA, SPI, SSC, UART/USART, USB
Peripherals	Brown-out Detect/Reset, DMA, POR, PWM, WDT
Number of I/O	28
Program Memory Size	512KB (512K x 8)
Program Memory Type	FLASH
EEPROM Size	-
RAM Size	96K x 8
Voltage - Supply (Vcc/Vdd)	1.65V ~ 3.6V
Data Converters	A/D 6x10b
Oscillator Type	Internal
Operating Temperature	-40°C ~ 85°C (TA)
Mounting Type	Surface Mount
Package / Case	48-VFQFN Exposed Pad
Supplier Device Package	48-QFN (7x7)
Purchase URL	https://www.e-xfl.com/product-detail/microchip-technology/at32uc3b1512-z1ur

5. Signals Description

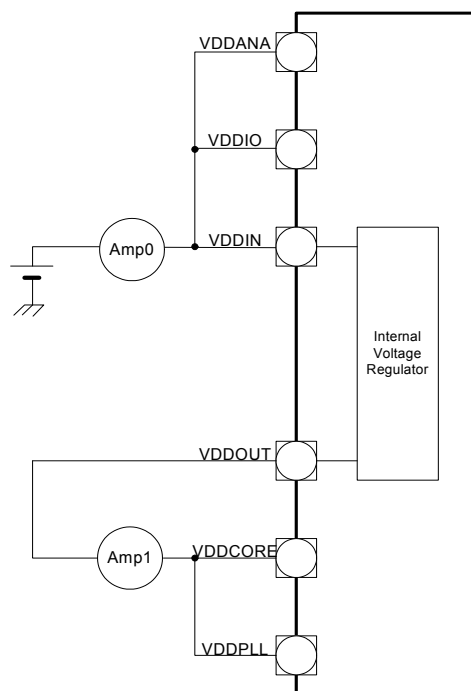
Figure 9-5. Measurement Setup

The values in [Table 9-10](#), [Table 9-11 on page 43](#) and [Table 9-12 on page 44](#) are measured values of power consumption with operating conditions as follows:

- $V_{DDIO} = V_{DDANA} = 3.3V$
- $V_{DDCORE} = V_{DDPLL} = 1.8V$
- $T_A = 25^{\circ}C$, $T_A = 85^{\circ}C$
- I/Os are configured in input, pull-up enabled.

The following tables represent the power consumption measured on the power supplies.
